Manhole Inspection Summary

Manhole # S41A2_012MH

Inspection ☐ Is Incomplete Rating: **4) Poor**

Location Address: **9th St.** Cross Street: **E. Patapsco Ave.**

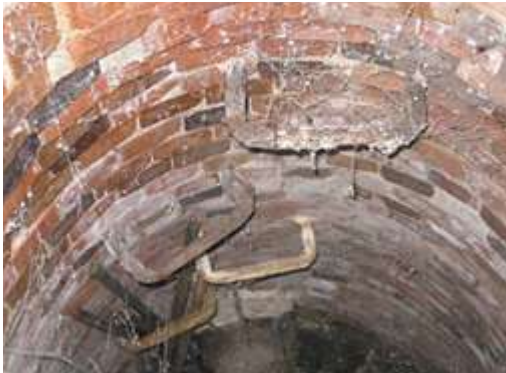
Steps Count: **4** Missing: **0** ☐ Corroded

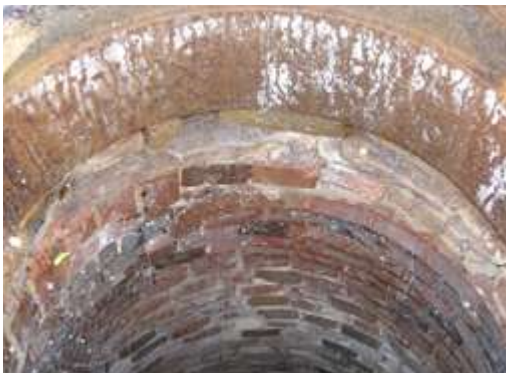
Defect 2

Frame Offset: **1.5** (in.) Condition: ☒ Sound ☐ Cracked ☐ Leaks

Chimney / Frame Adjustment ☒ Exists Material: **Brick** ☐ Parged Height: **8** (in.)
Condition: ☐ Sound ☐ Cracked ☐ Root Intrusion ☒ **Loose Brick** ☐ Deteriorated
Infiltration: ☒ None ☐ Joint ☐ Cracks ☐ Mortar ☐ Roots ☐ Wall

Fame offset/loose bricks

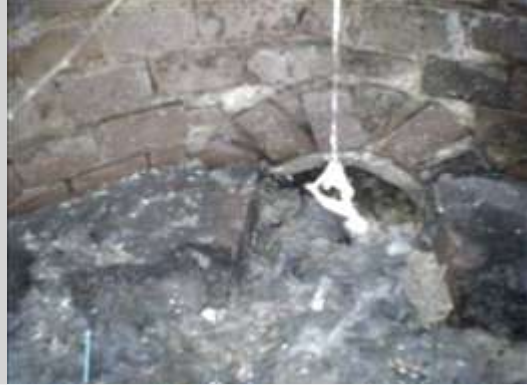
12 O'Clock Outflow

8 in. Circular Gravity Sewer
Pipe Out @ 12 O'Clock

Deposits: ☐ None ☒ **Mud** ☐ Sludge ☒ **Debris** ☐ Grease

Silt Depth: **5** (in.) Deposits Extent: **Heavy**

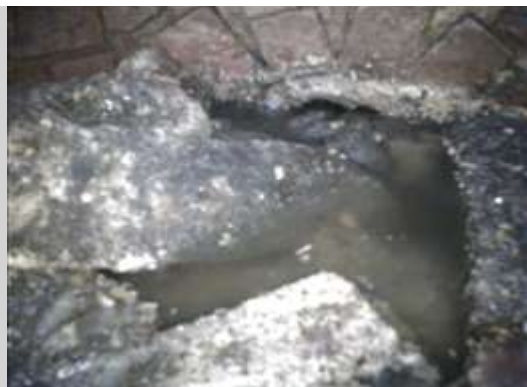
3 O'Clock Inflow

Comments **Large rock blocking pipe preventing measurement of influent pipe @ 3 O'clock**

6 in. Circular Service Sewer
Pipe In @ 3 O'Clock

Deposits: ☐ None ☐ **Mud** ☐ Sludge ☒ **Debris** ☐ Grease

Silt Depth: **5** (in.) Deposits Extent: **Heavy**

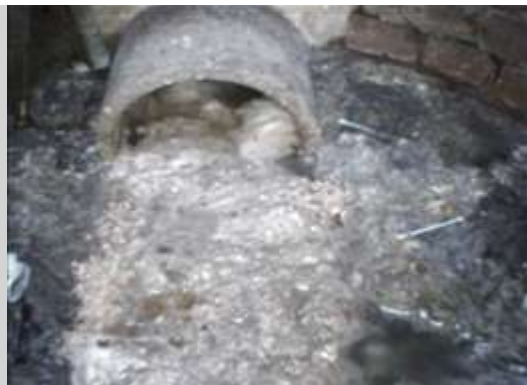
9 O'Clock Inflow

8 in. Circular Gravity Sewer
Pipe In @ 9 O'Clock

Deposits: ☐ None ☒ **Mud** ☐ Sludge ☒ **Debris** ☐ Grease

Silt Depth: **5** (in.) Deposits Extent: **Heavy**
